## **Failure Analysis of First-Stage Vane in a GT13E1 Gas Turbine at Combined Cycle Power Plant**

The investigated component was a first-stage vane from a GT13E1 gas turbine operating at PLTGU Tanjung Priok. The vane was manufactured from an Inconel 939 nickel-based superalloy (Darolia, 2013; Bogdan & Peter, 2024) and protected by a thermal barrier coating (TBC) system. To reduce excessive metal temperatures, TBC systems are applied to protect the metallic substrate from extreme thermal exposure and extend component service life (Campbell et al., 2008; Chang et al., 2023). During routine inspection, severe degradation was

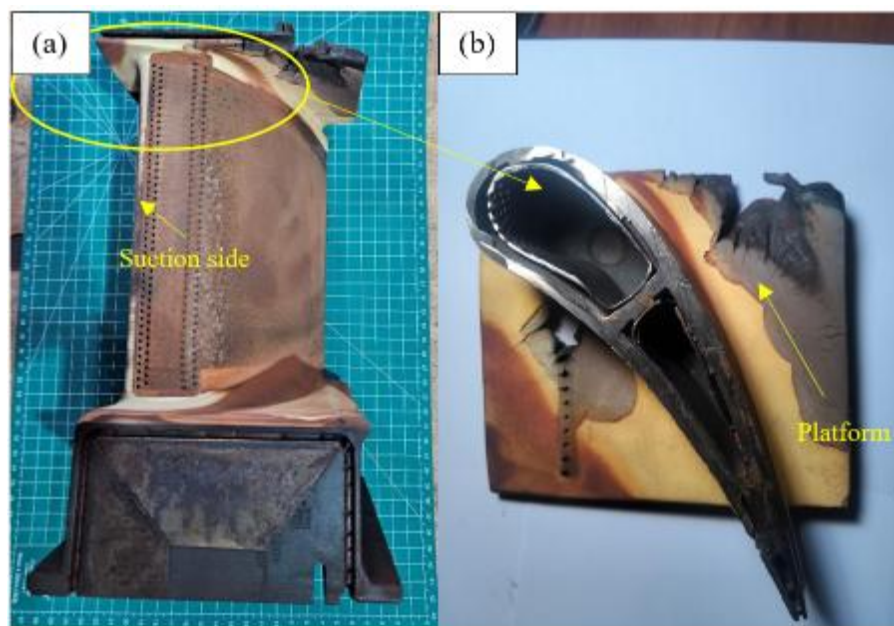
**Figure 1. (a) General view of first-stage vane consist of damage in platform endwall corner, (b) Macrography examination of damage**

The macroscopic examination of the first-stage vane revealed that the most severe damage was localized at the platform endwall corner region. Figure 1(b) shown the affected area exhibited coating degradation, dark surface discoloration, oxidation products, material loss, and visible crack formation. In contrast, the airfoil surface and cooling hole rows remained relatively intact, indicating that the damage was not initiated from conventional cooling-hole-related stress concentration.

The morphology of the damaged region suggests localized thermal distress characterized by excessive temperature exposure. The presence of severe oxidation and geometric distortion indicates that the protective TBC system had deteriorated prior to significant substrate damage. Once the coating was lost, the Inconel 939 substrate was directly exposed to high-temperature combustion gases, leading to progressive oxidation and weakening of the material.

These observations support the hypothesis that the failure originated from localised overheating at the platform endwall, likely due to secondary flow interactions and reduced cooling effectiveness in this region.

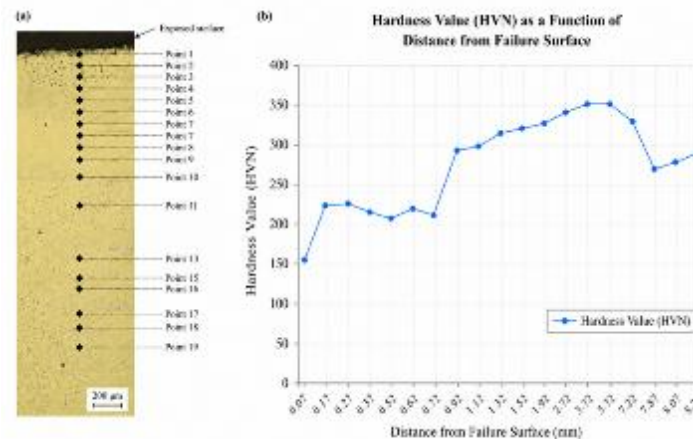
The hardness profile exhibits a pronounced gradient from the exposed failure surface toward the interior of the vane. The lowest hardness value of 155 HVN was recorded at a distance of 0.07 mm from the exposed surface. Within approximately 0.72 mm from the surface, hardness values remained relatively low, ranging between 155 and 227 HVN. This region is identified as a thermally degraded zone, where prolonged exposure to elevated temperatures following the loss of thermal protection promoted microstructural degradation and material softening (Scotson et al., 2024).

Beyond approximately 0.72 mm from the exposed surface, hardness values increased significantly and generally ranged between 250 and 350 HVN. Although several localized measurements exceeded 330 HVN, the overall hardness distribution remained relatively stable within the range commonly reported for service-exposed Inconel 939. The observed fluctuations are attributed to normal microstructural variations within the cast superalloy, including differences in precipitate distribution, carbide morphology, and local dendritic segregation.

**Figure 2. Microhardness evaluation in damage cross-section : (a) Indentation location, (b) Hardness profile**

At greater distances from the failure surface, the hardness profile became relatively stable, generally ranging between 250 and 320 HVN. This region is interpreted as the underlying Inconel 939 base material, where the original strengthening mechanisms remained largely preserved. The relatively constant hardness values indicate that thermal degradation was predominantly localized near the exposed surface and did not penetrate deeply into the substrate.

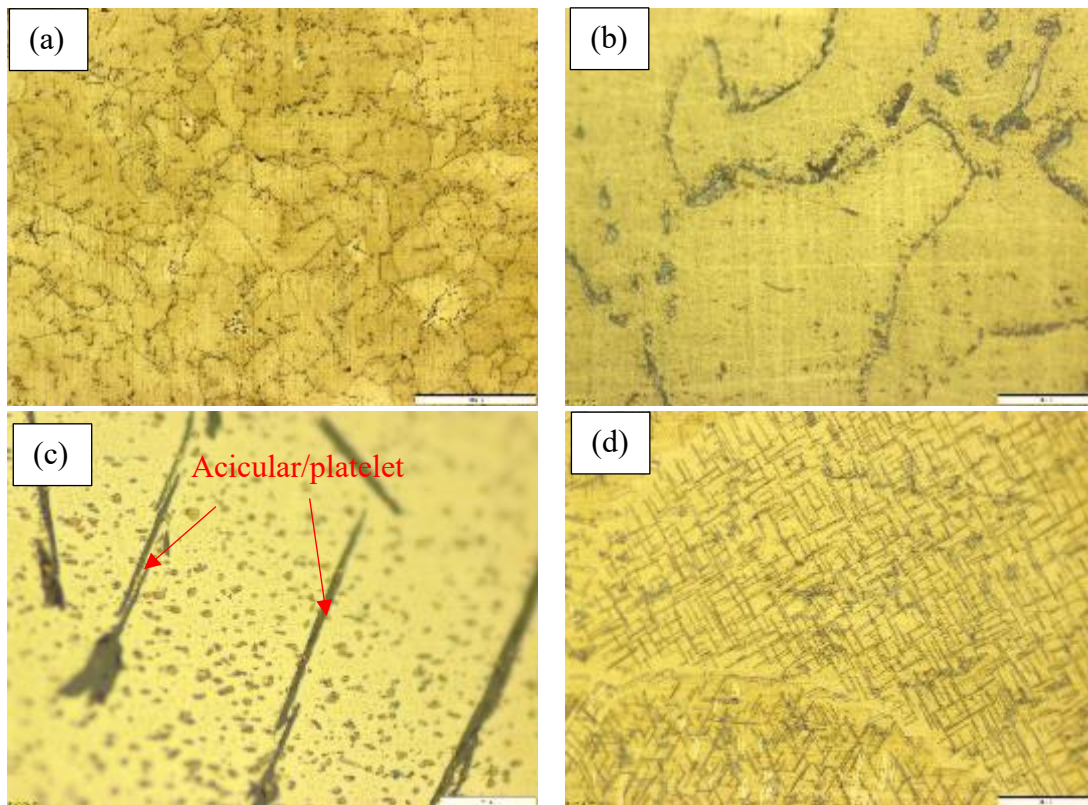
exhibits a clear microstructural gradient from the surface toward the interior, as shown in Figure. 3 (c). The near-surface region appears significantly degraded, characterized by a darkened layer and the absence of a clearly defined  $\gamma/\gamma'$  structure. This condition indicates severe oxidation and material degradation, suggesting that the protective coating system had deteriorated, exposing the substrate directly to high-temperature combustion gases. Beneath this degraded surface, the microstructure gradually transitions toward a more recognizable  $\gamma/\gamma'$  morphology (Miller, 2009).

**Figure 2. Metallographic microstructure of first stage vane: (a-b) reference region, (c) damaged region , (d) base metal region.**

Further microstructural changes are observed in the damaged region near the crack area, as shown in Figure. 3 (d). The microstructure exhibits a less homogeneous morphology compared with the reference region, suggesting microstructural evolution associated with prolonged thermal exposure. In addition, elongated acicular or platelet-like features were observed in the degraded region. The formation of these morphologies is commonly associated with microstructural instability during prolonged thermal exposure in nickel-based superalloys. However, definitive phase identification was beyond the scope of the present investigation (Rai et al., 2009).

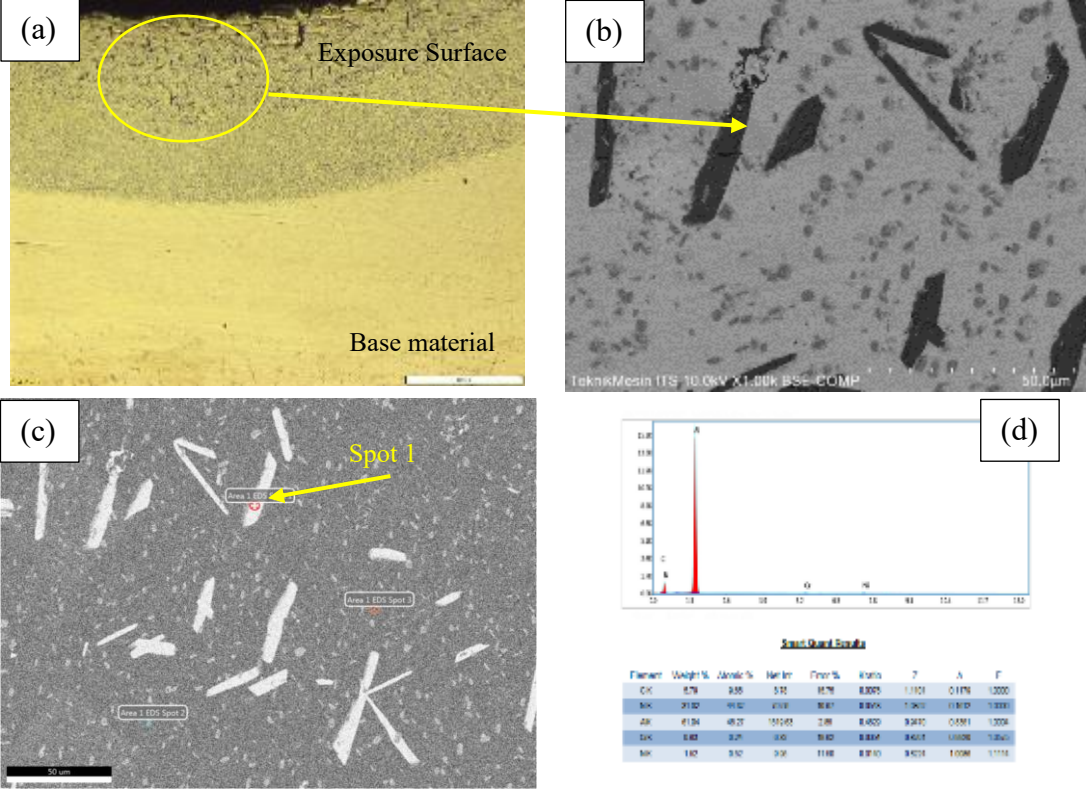
To further investigate the degradation mechanism of the first-stage vane, Scanning Electron Microscopy coupled with Energy Dispersive Spectroscopy (SEM-EDS) was performed on representative regions of the damage cross-section crack cross-section, and degraded surface. SEM observation revealed the presence of an acicular or needle-like microstructure embedded within the matrix, as shown in Figure 4 (b). This morphology was not observed in the reference specimen and is therefore considered a product of microstructural evolution during service exposure. EDS analysis performed on the acicular feature indicated significant aluminum enrichment, with the aluminum content reaching approximately 61 wt%, whereas the surrounding matrix retained the characteristic composition of Inconel 939 dominated by Ni, Cr, and Co. The formation of the acicular structure suggests that prolonged thermal exposure promoted phase transformation and microstructural instability within the substrate material (Lee et al., 2021).

**Figure 3. Identification of damage cross-section in failed vane : (a) Investigation region, (b) SEM image of precipitates, (c) EDS analysis location, (d) EDS spectrum result.**

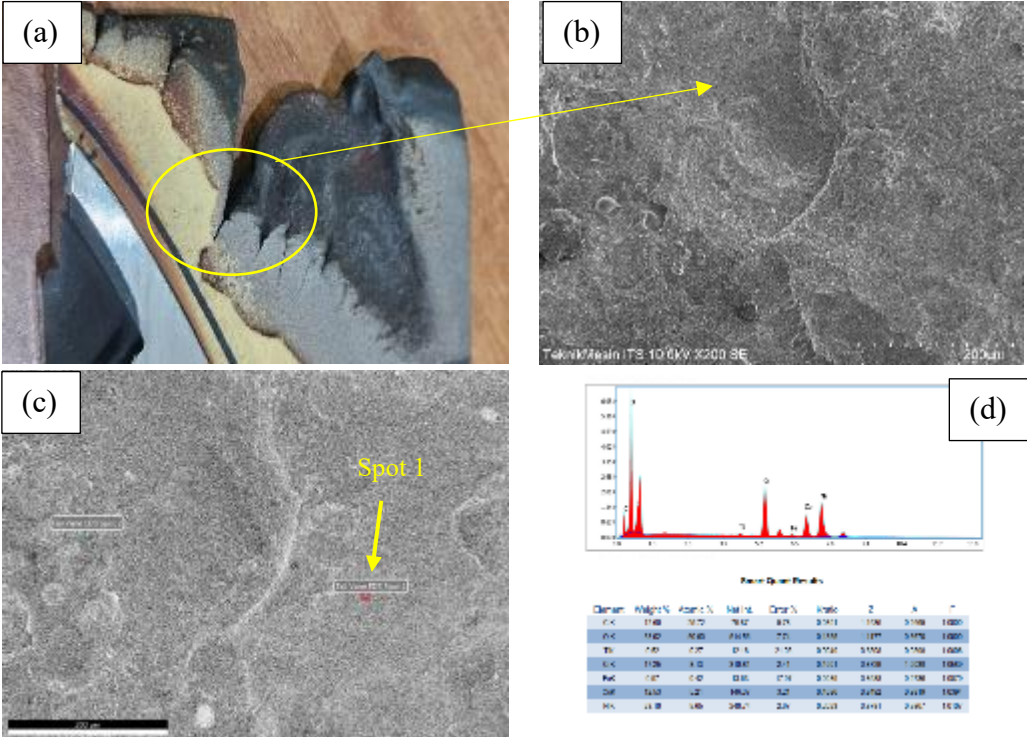
The next examination was conducted on the crack cross-section, as presented in Figure 5 (a). SEM images revealed oxidation products distributed along the crack path and adjacent grain boundaries shown in Figure 5 (b). EDS measurements detected elevated oxygen concentrations within these regions, indicating that high-temperature oxidation propagated inward through preferential diffusion paths. The presence of oxygen-rich phases inside the crack suggests that oxidation was not limited to the external surface but continued to develop progressively into the material after crack initiation (Shaikh et al., 2023).

**Figure 5. Identification of crack cross-section in failed vane : (a) Investigation region, (b) SEM image, (c) EDS analysis spot location. (d) EDS spectrum result.**  
 Source: Author's Laboratory Analysis (2024)

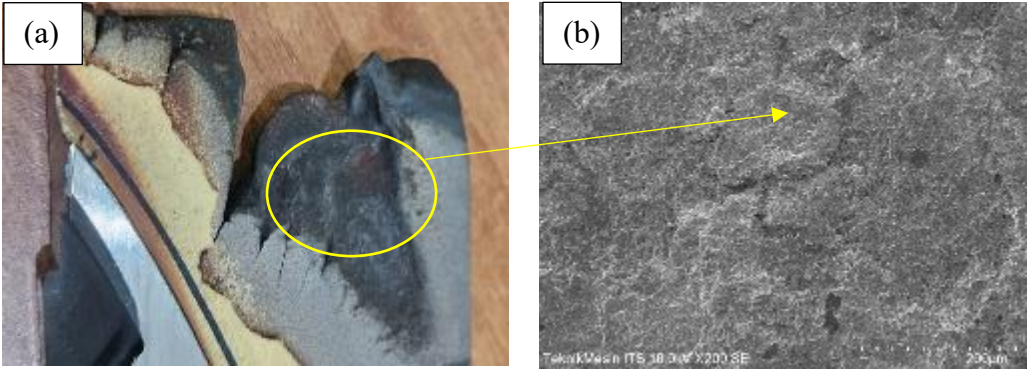
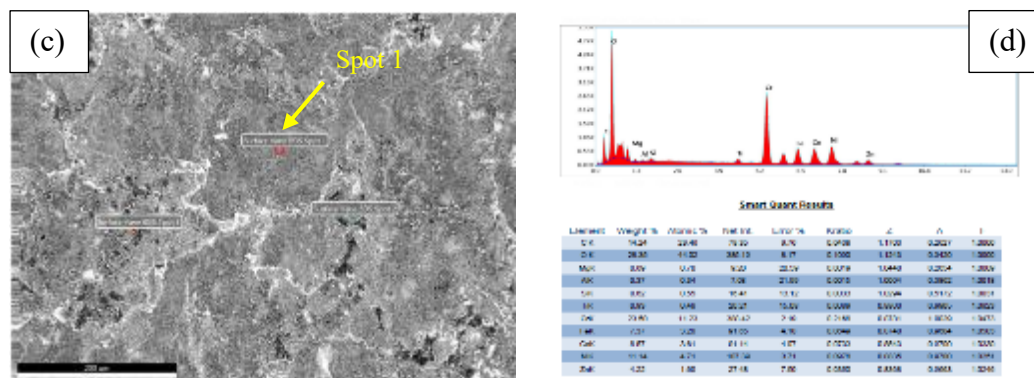
The morphology of the degraded surface is shown in Figure 6 (a). The exposed surface exhibited a rough and heterogeneous appearance characterized by microcracks, porosity, granular features, and oxidation products. Several regions displayed in Figure 6 (b) significant contrast differences, indicating variations in composition and degradation severity. EDS analysis in Figure 6 (d) confirmed the presence of oxygen-rich areas, demonstrating that extensive oxidation occurred after the thermal barrier coating system lost its protective function and the substrate became directly exposed to hot combustion gases.

**Figure 6. Identification of damage surface in failed vane : (a) Investigation region, (b) SEM image, (c) EDS analysis spot location. (d) EDS spectrum result.**

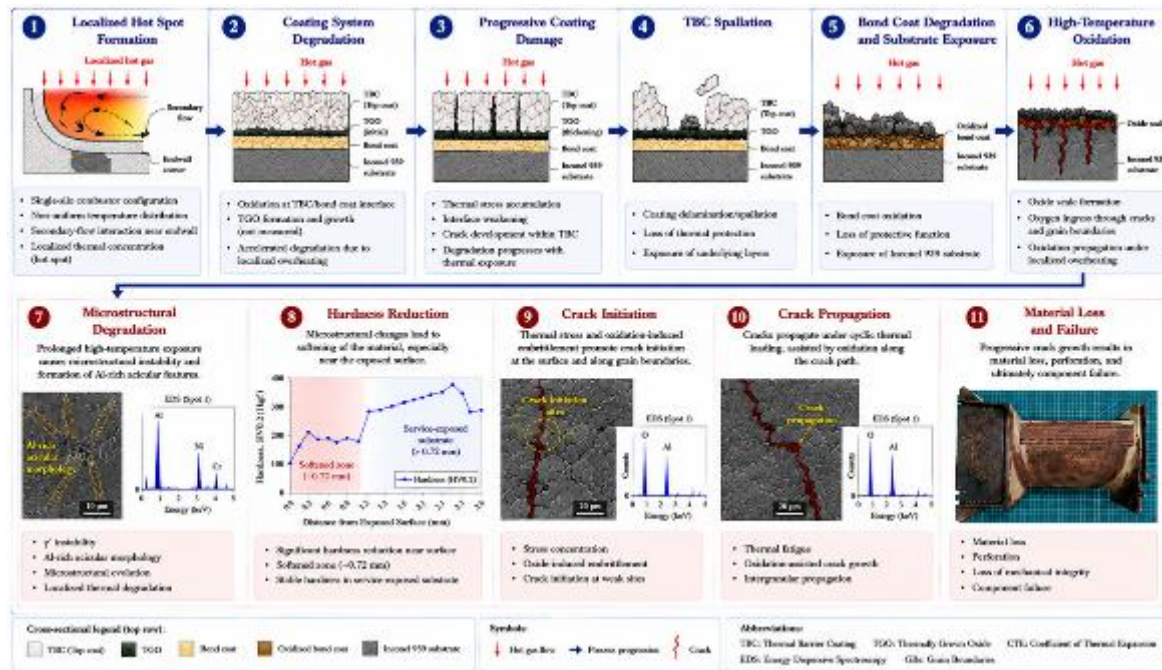
The degradation process is believed to have initiated during long-term operation under repeated thermal cycling conditions, as illustrated in stages 1–3 of Figure 7. Continuous exposure to high-temperature combustion gases from single-silo combustor configuration promoted progressive deterioration of the coating system. Oxidation occurring at the coating interface likely contributed to degradation of the protective layers and accumulation of thermal stresses resulting from thermal expansion mismatch between the coating system and the substrate. Although the formation and growth of a thermally grown oxide (TGO) layer were not directly examined in the present study, such mechanisms have been widely reported as contributing factors in TBC degradation (Mehboob et al., 2020).

The loss of the protective TBC exposed the underlying Inconel 939 substrate directly to the hot combustion gas environment. As a result, the local metal temperature increased, accelerating oxidation and microstructural degradation of the exposed material as illustrated in stage 4 of Figure 7. This condition significantly reduced the effectiveness of the thermal protection system and increased the local metal temperature (Raza et al., 2024).

**Figure 7. Proposed Failure Mechanism of GT 13E1 First-stage Vane Based On Experimental Observations**

Following exposure of the substrate, high-temperature oxidation progressively developed at the surface and propagated through grain boundaries and existing defects. This mechanism was supported by SEM-EDS analysis, which revealed elevated oxygen concentrations within the degraded region and along crack paths as shown in stage 5-6 of Figure 7. The presence of oxygen-rich areas indicates the formation of oxide products during service exposure. In addition, the observation of oxidized cracks suggests that oxidation occurred before or during crack propagation, contributing to the deterioration of material integrity and facilitating crack initiation.

Simultaneously, prolonged thermal exposure caused significant microstructural changes within the Inconel 939 substrate. As presented in stage 7 of Figure 7, metallographic observations revealed precipitate coarsening, acicular phase formation, and indications of carbide evolution compared with the expected microstructure of the alloy. These microstructural changes indicate thermal degradation of the strengthening phases and reduced resistance to high-temperature service conditions.

The reduction in mechanical properties was further evidenced by the hardness measurements. The hardness profile showed severe softening near the exposed surface as hardness profile shown in stage 8 of Figure 7. This hardness gradient demonstrates that hardness values were substantially lower than those measured in the underlying base material, indicating localized softening caused by thermal degradation and oxidation.

The combined effects of oxidation, microstructural degradation, localized hot-spot formation, and mechanical softening eventually facilitated crack initiation and propagation under cyclic thermal loading conditions as illustrated in stage 9-10 of Figure 7. As crack growth continued during operation, progressive material loss occurred within the platform endwall region, ultimately producing the severe damage morphology observed during inspection.
