## **Failure Analysis of First-Stage Vane in a GT13E1 Gas Turbine at Combined Cycle Power Plant**

The investigated component was a first-stage vane from a GT13E1 gas turbine operating at PLTGU Tanjung Priok. The vane was manufactured from an Inconel 939 nickel-based superalloy (Darolia, 2013; Bogdan & Peter, 2024) and protected by a thermal barrier coating (TBC) system. To reduce excessive metal temperatures, TBC systems are applied to protect the metallic substrate from extreme thermal exposure and extend component service life (Campbell et al., 2008; Chang et al., 2023). During routine inspection, severe degradation was

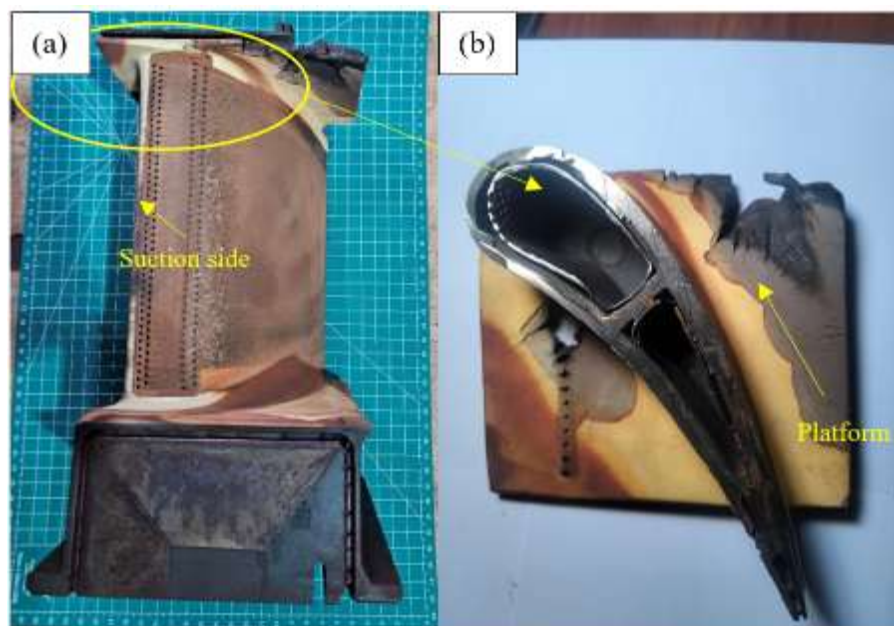
**Figure 1. (a) General view of first-stage vane consist of damage in platform endwall corner, (b) Macrography examination of damage**

The macroscopic examination of the first-stage vane revealed that the most severe damage was localized at the platform endwall corner region. Figure 1(b) shown the affected area exhibited coating degradation, dark surface discoloration, oxidation products, material loss, and visible crack formation. In contrast, the airfoil surface and cooling hole rows remained relatively intact, indicating that the damage was not initiated from conventional cooling-hole-related stress concentration.

The morphology of the damaged region suggests localized thermal distress characterized by excessive temperature exposure. The presence of severe oxidation and geometric distortion indicates that the protective TBC system had deteriorated prior to significant substrate damage. Once the coating was lost, the Inconel 939 substrate was directly exposed to high-temperature combustion gases, leading to progressive oxidation and weakening of the material.

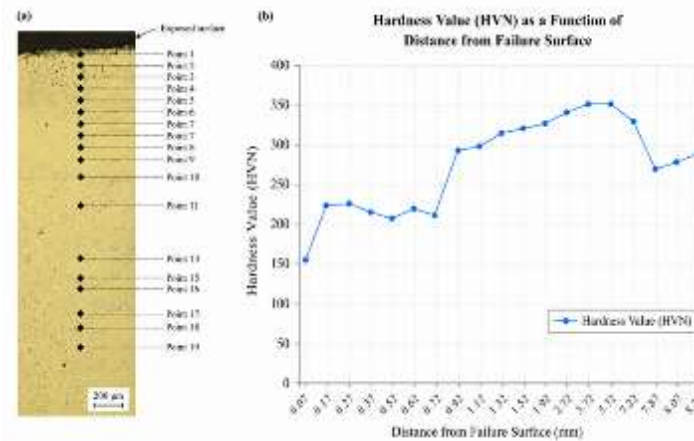
The hardness profile exhibits a pronounced gradient from the exposed failure surface toward the interior of the vane. The lowest hardness value of 155 HVN was recorded at a distance of 0.07 mm from the exposed surface. Within approximately 0.72 mm from the surface, hardness values remained relatively low, ranging between 155 and 227 HVN. This region is identified as a thermally degraded zone, where prolonged exposure to elevated temperatures following the loss of thermal protection promoted microstructural degradation and material softening (Scotson et al., 2024).

Beyond approximately 0.72 mm from the exposed surface, hardness values increased significantly and generally ranged between 250 and 350 HVN. Although several localized measurements exceeded 330 HVN, the overall hardness distribution remained relatively stable within the range commonly reported for service-exposed Inconel 939. The observed fluctuations are attributed to normal microstructural variations within the cast superalloy, including differences in precipitate distribution, carbide morphology, and local dendritic segregation.

**Figure 2. Microhardness evaluation in damage cross-section : (a) Indentation location, (b) Hardness profile**

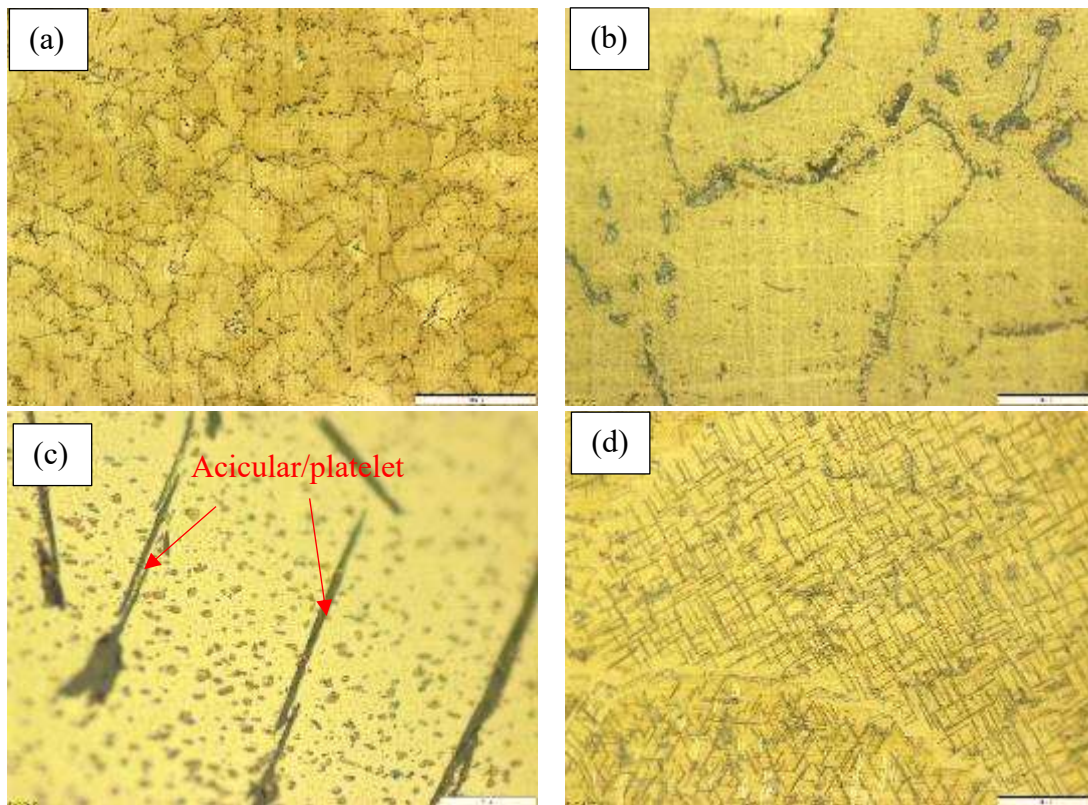
exhibits a clear microstructural gradient from the surface toward the interior, as shown in Figure. 3 (c). The near-surface region appears significantly degraded, characterized by a darkened layer and the absence of a clearly defined  $\gamma/\gamma'$  structure. This condition indicates severe oxidation and material degradation, suggesting that the protective coating system had deteriorated, exposing the substrate directly to high-temperature combustion gases. Beneath this degraded surface, the microstructure gradually transitions toward a more recognizable  $\gamma/\gamma'$  morphology (Miller, 2009).

**Figure 2. Metallographic microstructure of first stage vane: (a-b) reference region, (c) damaged region , (d) base metal region.**

Further microstructural changes are observed in the damaged region near the crack area, as shown in Figure. 3 (d). The microstructure exhibits a less homogeneous morphology compared with the reference region, suggesting microstructural evolution associated with prolonged thermal exposure. In addition, elongated acicular or platelet-like features were observed in the degraded region. The formation of these morphologies is commonly associated with microstructural instability during prolonged thermal exposure in nickel-based superalloys. However, definitive phase identification was beyond the scope of the present investigation (Rai et al., 2009).

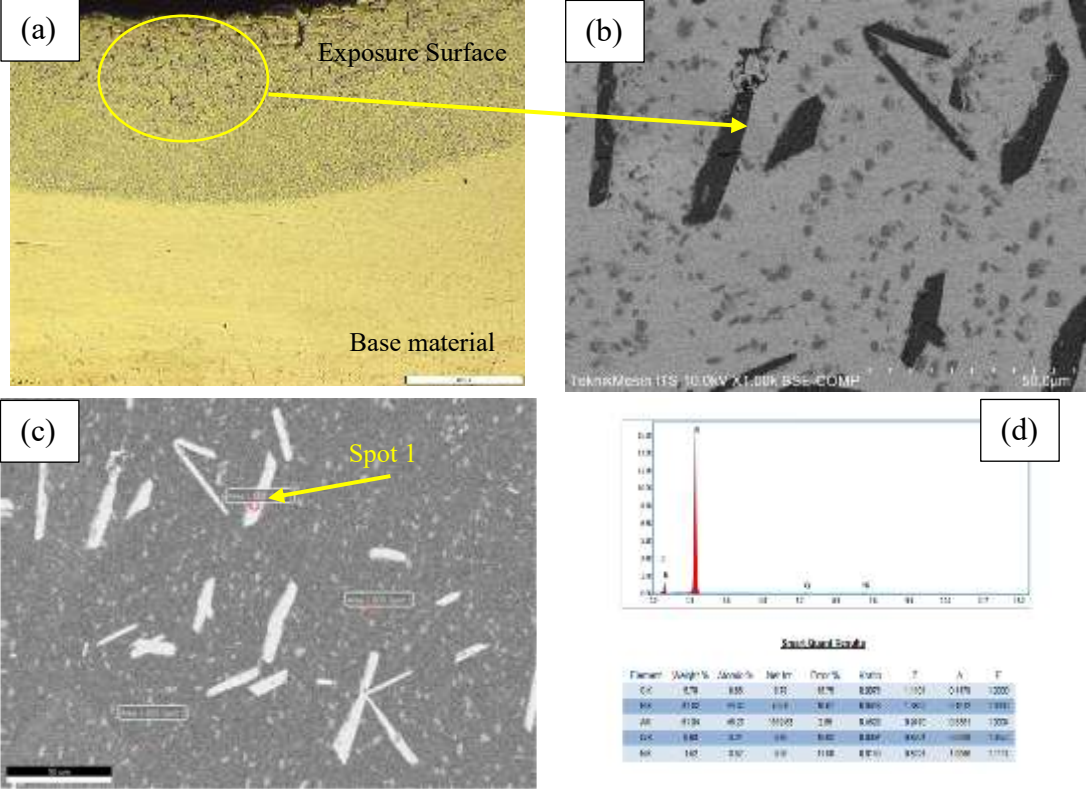
To further investigate the degradation mechanism of the first-stage vane, Scanning Electron Microscopy coupled with Energy Dispersive Spectroscopy (SEM-EDS) was performed on representative regions of the damage cross-section crack cross-section, and degraded surface. SEM observation revealed the presence of an acicular or needle-like microstructure embedded within the matrix, as shown in Figure 4 (b). This morphology was not observed in the reference specimen and is therefore considered a product of microstructural evolution during service exposure. EDS analysis performed on the acicular feature indicated significant aluminum enrichment, with the aluminum content reaching approximately 61 wt%, whereas the surrounding matrix retained the characteristic composition of Inconel 939 dominated by Ni, Cr, and Co. The formation of the acicular structure suggests that prolonged thermal exposure promoted phase transformation and microstructural instability within the substrate material (Lee et al., 2021).

**Figure 3. Identification of damage cross-section in failed vane : (a) Investigation region, (b) SEM image of precipitates, (c) EDS analysis location, (d) EDS spectrum result.**

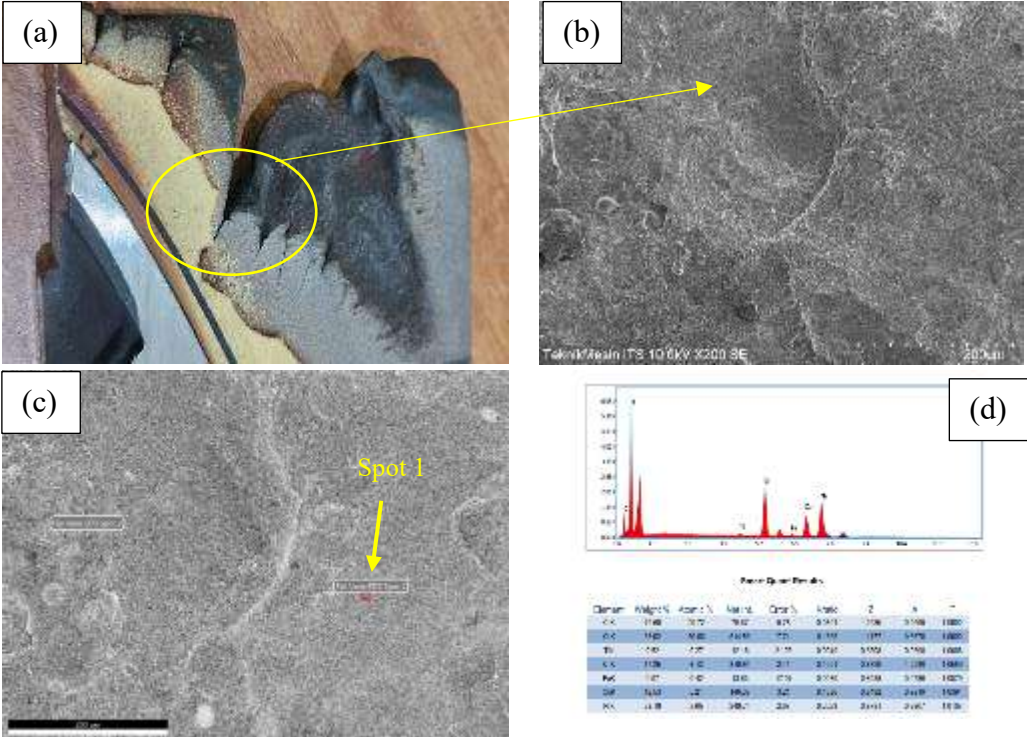
The next examination was conducted on the crack cross-section, as presented in Figure 5 (a). SEM images revealed oxidation products distributed along the crack path and adjacent grain boundaries shown in Figure 5 (b). EDS measurements detected elevated oxygen concentrations within these regions, indicating that high-temperature oxidation propagated inward through preferential diffusion paths. The presence of oxygen-rich phases inside the crack suggests that oxidation was not limited to the external surface but continued to develop progressively into the material after crack initiation (Shaikh et al., 2023).

**Figure 5. Identification of crack cross-section in failed vane : (a) Investigation region, (b) SEM image, (c) EDS analysis spot location. (d) EDS spectrum result.**  
Source: Author's Laboratory Analysis (2024)

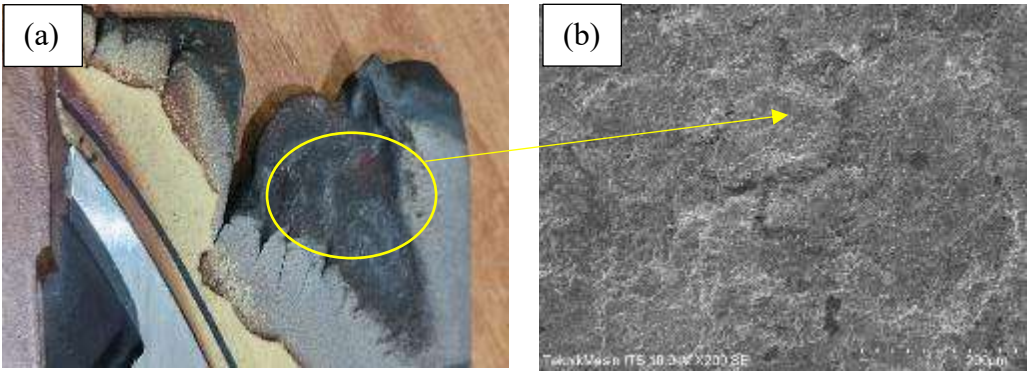
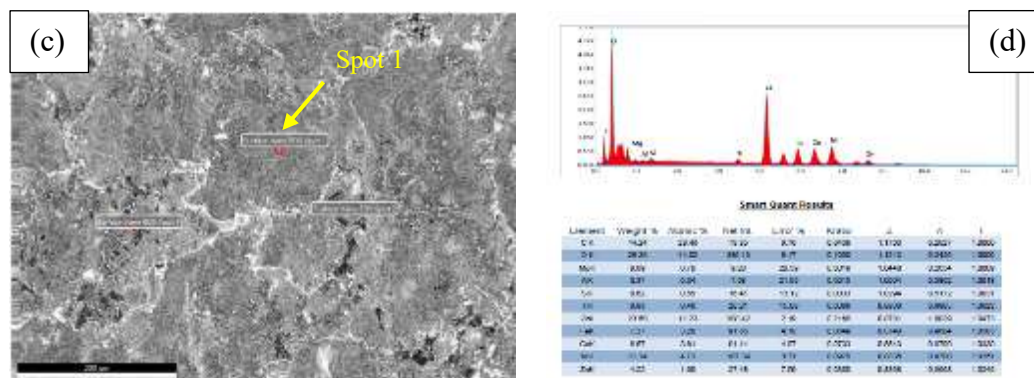
The morphology of the degraded surface is shown in Figure 6 (a). The exposed surface exhibited a rough and heterogeneous appearance characterized by microcracks, porosity, granular features, and oxidation products. Several regions displayed in Figure 6 (b) significant contrast differences, indicating variations in composition and degradation severity. EDS analysis in Figure 6 (d) confirmed the presence of oxygen-rich areas, demonstrating that extensive oxidation occurred after the thermal barrier coating system lost its protective function and the substrate became directly exposed to hot combustion gases.

**Figure 6. Identification of damage surface in failed vane : (a) Investigation region, (b) SEM image, (c) EDS analysis spot location. (d) EDS spectrum result.**

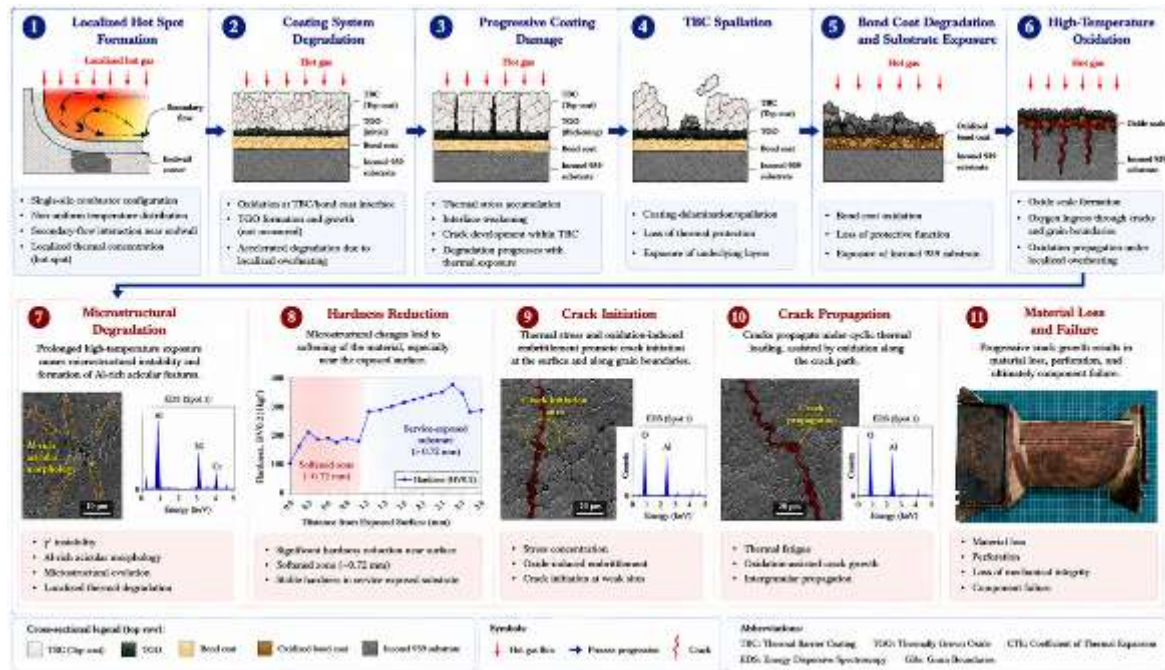
Based on the results obtained from visual inspection, hardness testing, metallographic examination, and SEM-EDS characterization, a failure mechanism is proposed to explain the degradation of the first-stage vane. The proposed degradation sequence, developed from the experimental observations and supported by established degradation mechanisms reported in the literature, is summarized in Figure 7.

The degradation process is believed to have initiated during long-term operation under repeated thermal cycling conditions, as illustrated in stages 1–3 of Figure 7. Continuous exposure to high-temperature combustion gases from single-silo combustor configuration promoted progressive deterioration of the coating system. Oxidation occurring at the coating interface likely contributed to degradation of the protective layers and accumulation of thermal stresses resulting from thermal expansion mismatch between the coating system and the substrate. Although the formation and growth of a thermally grown oxide (TGO) layer were not directly examined in the present study, such mechanisms have been widely reported as contributing factors in TBC degradation (Mehboob et al., 2020).

Simultaneously, prolonged thermal exposure caused significant microstructural changes within the Inconel 939 substrate. As presented in stage 7 of Figure 7, metallographic observations revealed precipitate coarsening, acicular phase formation, and indications of carbide evolution compared with the expected microstructure of the alloy. These microstructural changes indicate thermal degradation of the strengthening phases and reduced resistance to high-temperature service conditions.

The reduction in mechanical properties was further evidenced by the hardness measurements. The hardness profile showed severe softening near the exposed surface as hardness profile shown in stage 8 of Figure 7. This hardness gradient demonstrates that hardness values were substantially lower than those measured in the underlying base material, indicating localized softening caused by thermal degradation and oxidation.

The combined effects of oxidation, microstructural degradation, localized hot-spot formation, and mechanical softening eventually facilitated crack initiation and propagation under cyclic thermal loading conditions as illustrated in stage 9-10 of Figure 7. As crack growth continued during operation, progressive material loss occurred within the platform endwall region, ultimately producing the severe damage morphology observed during inspection.
